OLYMPIC'S EXPANSION JOINTS

Olympic's Expansion Joints

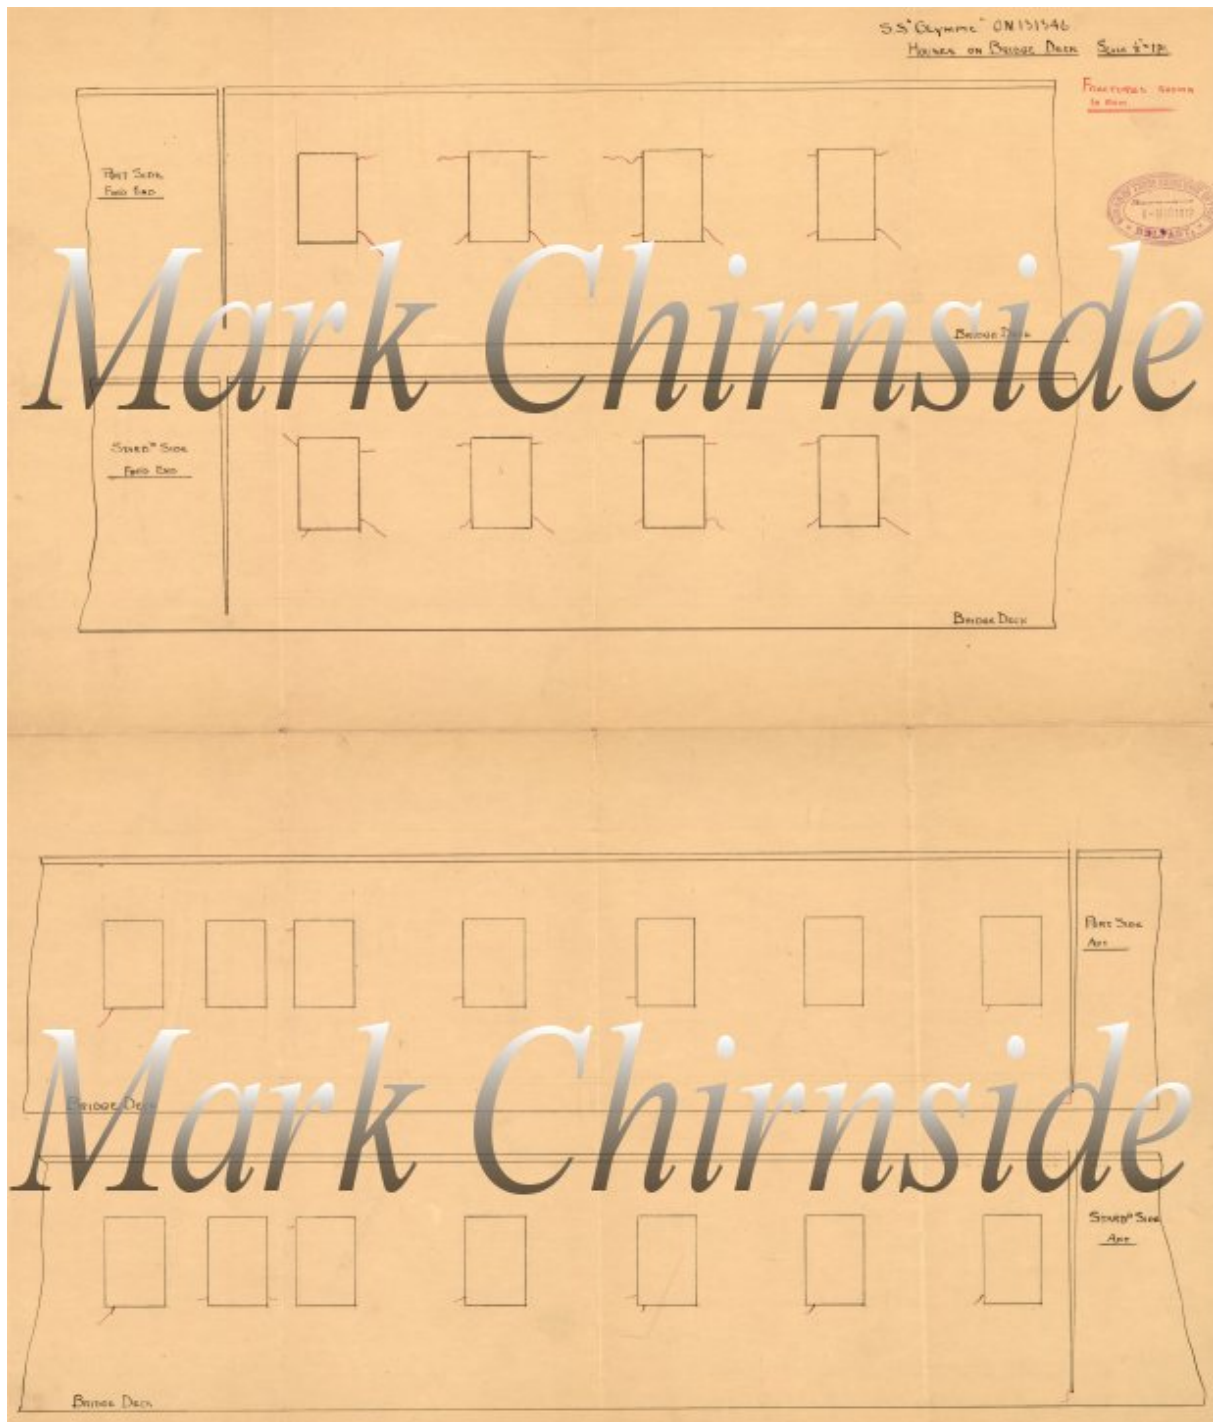
Above: Although simplistic, as they do not show the intricate details of the bridge deck's thin side plating or expansion joints, these diagrams give a good idea of the pattern of fractures that were localised at the corners of windows close to each of the expansion joints - particularly towards the forward end of Olympic's B-deck. (Courtesy National Archives, Author's Collection.)

By early 1912, *Olympic* had been in service for half a year, and experienced two very heavy storms in December 1911 and January 1912. When she was dry-docked for a new propeller blade to be fitted, early in March 1912 some signs of 'undue stress' were observed. On the bridge deck, B, there were a number of fractures at the corners of rectangular windows near

the expansion joints, while 'one very short fracture only was found in the houses on the promenade deck [A].' Fortunately the fractures were 'confined entirely to what is shown here, neither the promenade deck or bridge deck plating nor the bulwark plating at the sides showing any signs.'

It will be observed that these fractures have occurred at the portion of the [deck] houses between the expansion openings and near to the openings.

It was *Olympic's* aft expansion joint that was observed to have fractured at the light plating near the base. That would seem to indicate that it had opened more than anticipated. At the aft end of the deck, there was far less fracturing yet spread over a wider area, whereas at the forward end the fracturing was more extensive but around fewer windows. What seems
