TITANIC: ALLEGATIONS & EVIDENCE

By Mark Chirnside

This article was first published in the *Titanic International Society's Voyage* 94 December 2015: Pages 55-60.

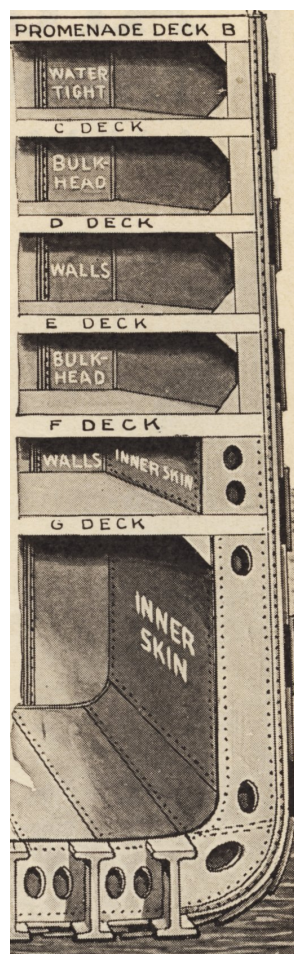
Left: An illustration of *Olympic*'s new watertight inner skin, fitted during the 1912-13 refit and running the length of the boiler and engine rooms. The White Star Line used in promotional material to reassure the travelling public. (*Harper's Magazine*, 1913/Author's collection)

It was difficult to provide additional longitudinal watertight protection in an existing ship. The boiler and machinery layout was already established and impossible to change, although the middle boiler in boiler room 5 was reduced in size on *Olympic* to help make way for the inner skin (*Britannic* was wider so it was not an issue). Nonetheless, the inner skin served its purpose. In September 1918, a torpedo slammed into *Olympic*'s port side amidships and pierced the outer hull. It failed to explode, but the resultant damage caused several sections of the inner skin to flood. The damage

Officials from Harland & Wolff and the White Star Line said publicly and privately that the purpose of the new inner skin was to improve the ships' watertight subdivision; the structural design of the inner skin supports this; and the practical experience of *Olympic's* encounter with a German torpedo in September 1918 demonstrates clearly the value of the inner skin in cases where the outer plating had been pierced.

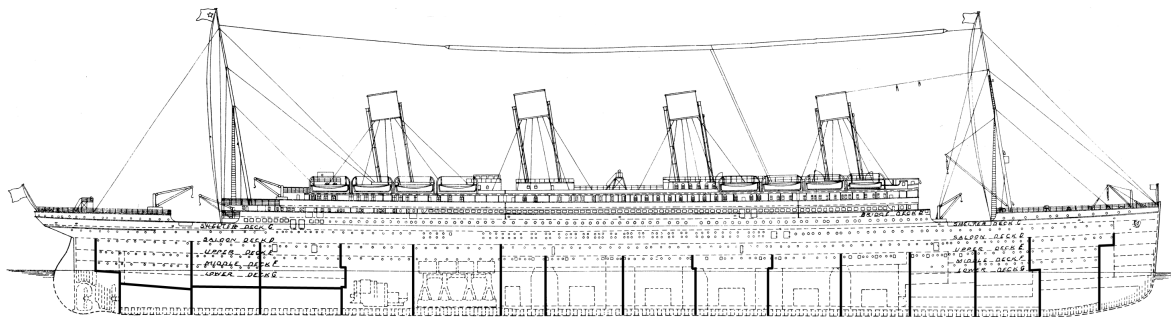
Above: *Olympic's* watertight subdivision in 1911 – the same as *Titanic's*. (Bruce Beveridge, © 2010/Author's collection)

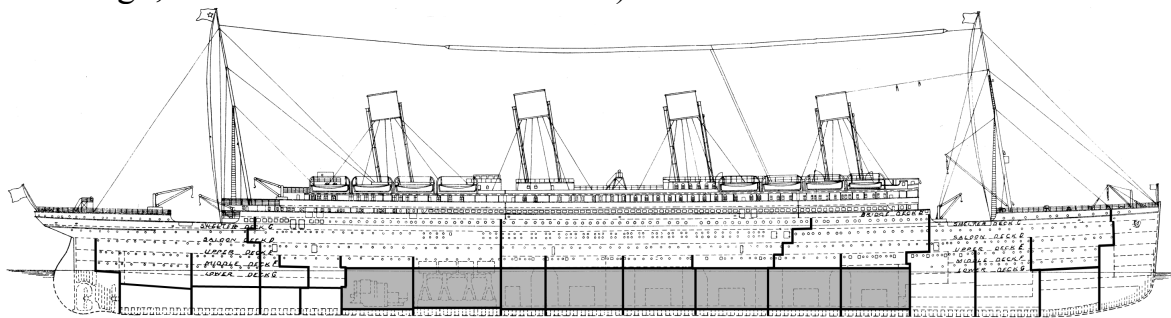
Below: After the 1912-13 refit, *Olympic* had seen considerable changes: additional watertight protection had been fitted in the forward hold; the extent of the inner skin is shaded in grey amidships; five watertight bulkheads extended up as far as the underside of the bridge deck, B; three watertight bulkheads aft had been lowered in height; and an additional watertight bulkhead fitted dividing the electric engine room. (Bruce Beveridge, © 2010/Author's collection)
