RMS *OLYMPIC*: THE MIS-DATED REFIT

By Mark Chirnside

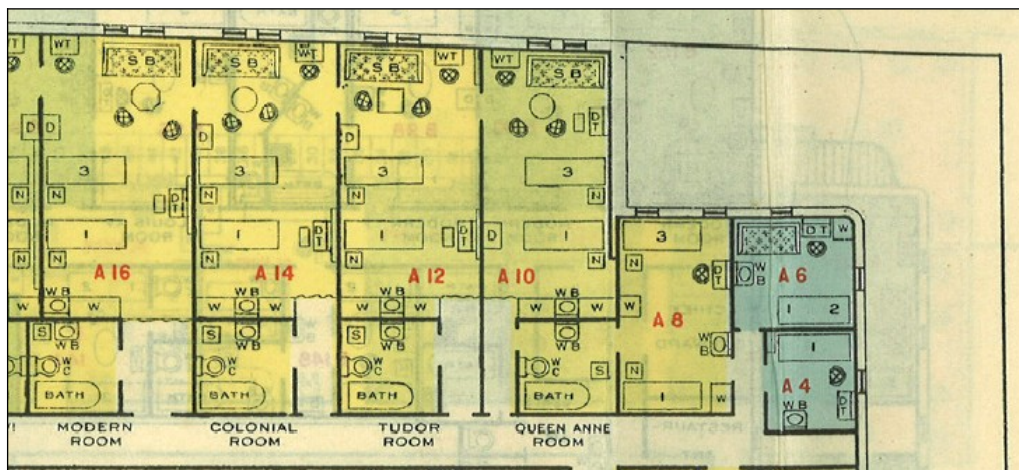
Above: This summer 1934 plan shows the forward end of B-deck on the port side, after the new first class suites had been installed. From left to right, a few of the many decorative styles are indicated: Modern A16, Colonial A14, Tudor A12, and Queen Anne A10. The lettering of the first class rooms has changed, since B-deck had been renamed A-deck by this time. The deckhouse corner formed by staterooms A8, A6 and A4 indicates the original width of the deckhouse, before the promenade was removed to make room for the new suites. These three rooms were in the small minority of first class accommodation on this deck without their own private facilities, yet the occupants had a fine view. At the top of the plan the narrowing of the hull is visible – as each suite closer to the bow (on the right) is shorter than the previous one. The spacing of the suite windows is visible on the plan, showing that they were cut in pairs and replaced the evenly-spaced windows that had been here (forming the enclosed promenade) before the new suites were added. This change is visible in exterior photographs of the *Olympic* taken before and after the new suites were installed. (Author's collection)

'sixteen new staterooms in the styles of Louis XVI and Queen Anne were built and fifty-three additional private bathrooms were installed in the first class quarters. To provide the space necessary for these alterations a section of the B-deck forward of the main companionway was utilised and the rooms were extended to the side of the ship.'

'During the "lay-up" the first class accommodation on the bridge deck for about 98 feet at the fore end has been carried out to the [ship's] side. The plating is 0.38 inches and [the] framing 6½ x 4½ x 0.5 inch angles at the normal [hull] frame
